Vassar College

Getty Foundation Campus Heritage Grant

Historic Preservation Design Manual

June 15, 2007

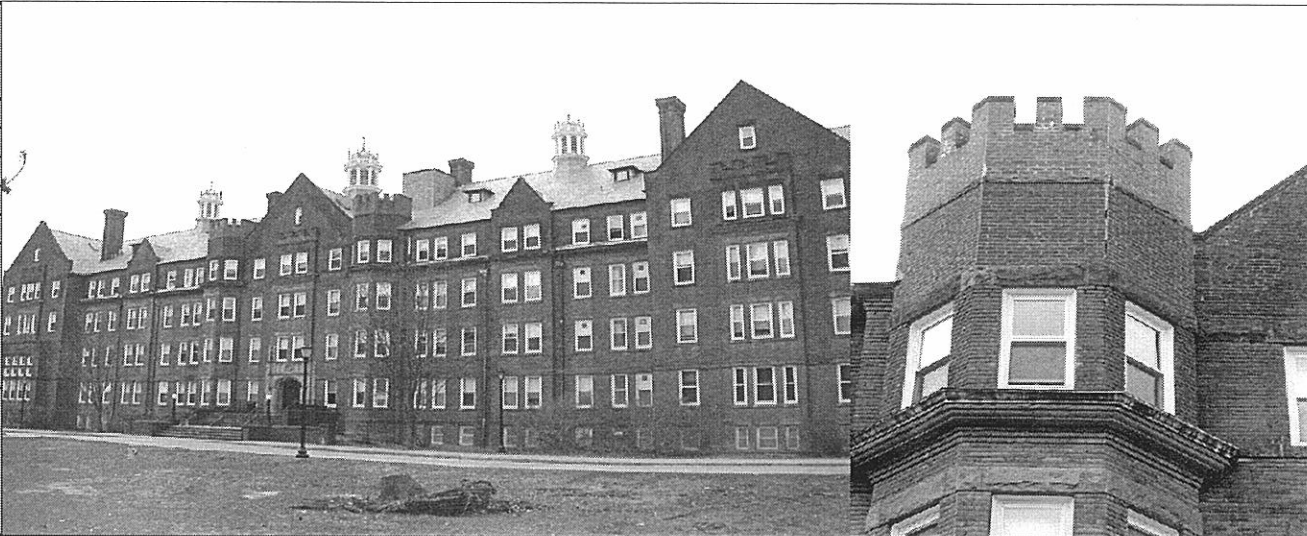
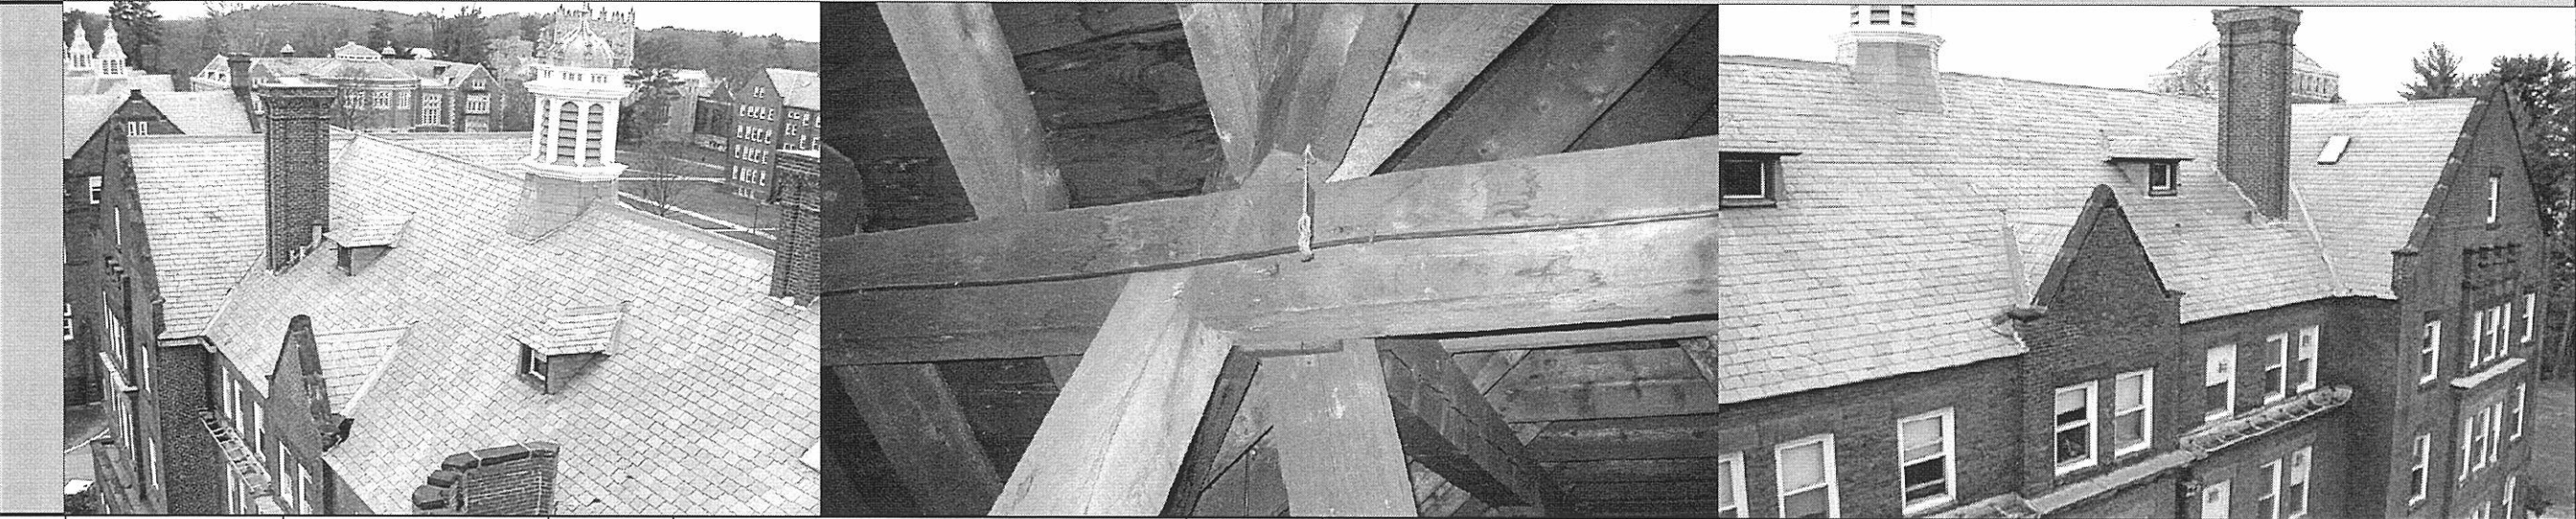
Item	Year of Installation	End of Service Life Year				2007	2008- 2010	2011- 2016	2017+		
1	Roof Construction														
1a	Pitched	Vermont fading green slates, few replacements.	Good	All slopes.	1980	2105	Weathertight	Limited review, 2004, with minor repairs, 2005.	Replace missing or cracked slates as needed, possibly on 5 yr cycle.			X		125+	Anticipated replacement in 2105.
		Copper flashings and built-in gutter system.	Poor	All areas	1950	2010	Weathertight, Structurally Sound	Limited review and repairs, 2005.	Replace all flashings, and install through-wall flashing under coping stones.			X		60	Full rehabilitation of copper flashings, including installation of through-wall flashing merits review of slate replacement as well.
1b	Low Slope	Low-rise portion of building, presumably with coal tar system.	Fair	Localized area.	Unknown, presumed 1980	2010	Weathertight	None	Replace as part of a full roof rehabilitation.			X		Depends upon selected system.

1c	Other, Chimneys	Five chimneys constructed with two wythes of brick with bluestone caps.	Fair	Weathered masonry joints accelerates deterioration of the assemblies.	1901	2001	Weathertight, Structurally Sound	Limited review in 2004.	Repoint 100% during next masonry rehabilitation cycle.		X			50	
1d	Other, Dormers	Similar to main roof.	Good	All slopes.	1980	2105	Weathertight	Limited review, 2005.	Replace missing or cracked slates as needed.			X			Replace deteriorated slates during flashing rehabilitation project.
1e	Other, Cupolas	Timber framed, louvered painted walls with painted terne cap.	Fair	Louvers leak, and finials have been falling off.	1901	Unlimited with maintenance.	Weathertight, Aesthetically pleasing.	Limited review, 2004.	Review conditions, and restore paint system. Secure or replace loose finials.			X			Unlikely all present components are original, and further investigation required.

2	Exterior Walls Construction														
2a	Mass Masonry, Composite	Typical walls: Brick masonry.	Fair	Areas under gutters and coping stone mortar joints are open.	1901	Unlimited with maintenance.	Weathertight, structurally sound.	Limited review in 2004, and stabilization in 2005.	Address roofing, then repoint affected areas. Until then, masonry under gable ends repointed or rebuilt.		X			50+	Improving the roof drainage system will decrease rate of deterioration.
		Brownstone trim elements: typical window lintels, coping stones, beltcourse.	Fair	Open mortar joints undermine weathertightness.	1901	Unlimited with maintenance.	Weathertight.	Limited review, 2004, and some rehabilitation, 2005.	Remove coping stones and reset atop through-wall flashing.		X			50+

Item	Year of Installation	End of Service Life Year				2007	2008- 2010	2011- 2016	2017+		
2b	Mass Masonry, Composite	Parapets: Brick masonry capped with brownstone.	Fair	Similar to chimneys, on-going exposure has deteriorated masonry. Unstable elements removed, 2005 & 2006.	1901	Unlimited with maintenance.	Structurally stable.	Limited review, 2004 & 2006.	Rebuild parapets to restore appearance and structural stability.		X			100+	
3	Windows														
3a	Operable, single-hung.	Wood frame and sashes.	Fair	Window frames not sealed at perimeter, aesthetic concerns.	1980	2010	Weathertight, aesthetically pleasing.	none	Review window systems and replace with long service life option.		X	X		30	Windows appear to remain functional but are nearing end of service life.
4	(Other Building Components- as required)														
4a	Mass Masonry, Composite	Main Quadrangle entrance: original brownstone elements, presumed to be framed by brick piers.	Fair	Weathered appearance is aesthetically displeasing.	1901	2000	Structurally stable, aesthetically pleasing.	Limited review, 2004 and 2006.	Rebuild 100%.			X		100+	To be coordinated with plans for interior renovation of residence hall.

4b	Mass Masonry, Composite	Main Road entrance: original brownstone elements, new brick.	Excellent	Entire staircase.	2005	2105	Structurally stable, aesthetically pleasing.	Rebuilt in 2005.	No recommended action.					100+	
4c	Mass Masonry, Composite	Low-rise staircase: steel framed with concrete, brick, bluestone, and brownstone composite masonry.	Fair	Staircase partially rebuilt, but on-going deterioration and corrosion of steel.	1984	2014	Structurally stable, aesthetically pleasing.	Limited review, 2006.	Selective rebuild, replacement of staircase treads, localized masonry repairs.			X		40	Condition of staircase does not mandate immediate intervention, but may consider coordination of this rehabilitation within larger masonry program.
4d	Interior wood roof framing	North end of roof: roof framing of north-most gable.	Excellent	Framing unconstrained. Roof dilating and generating open masonry, and breaking perimeter window seals with masonry.	2006	2106	Structurally stable.	Investigation and full repair executed, Summer 2006.	No recommended action.					100+	Service life of supplementary framing ties indefinite.

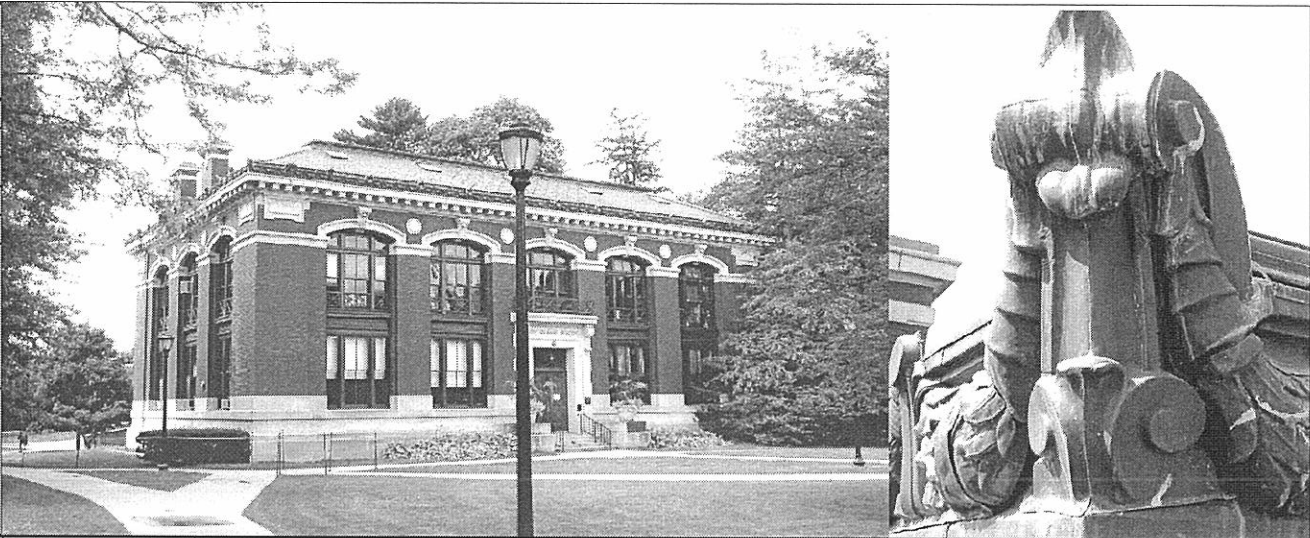
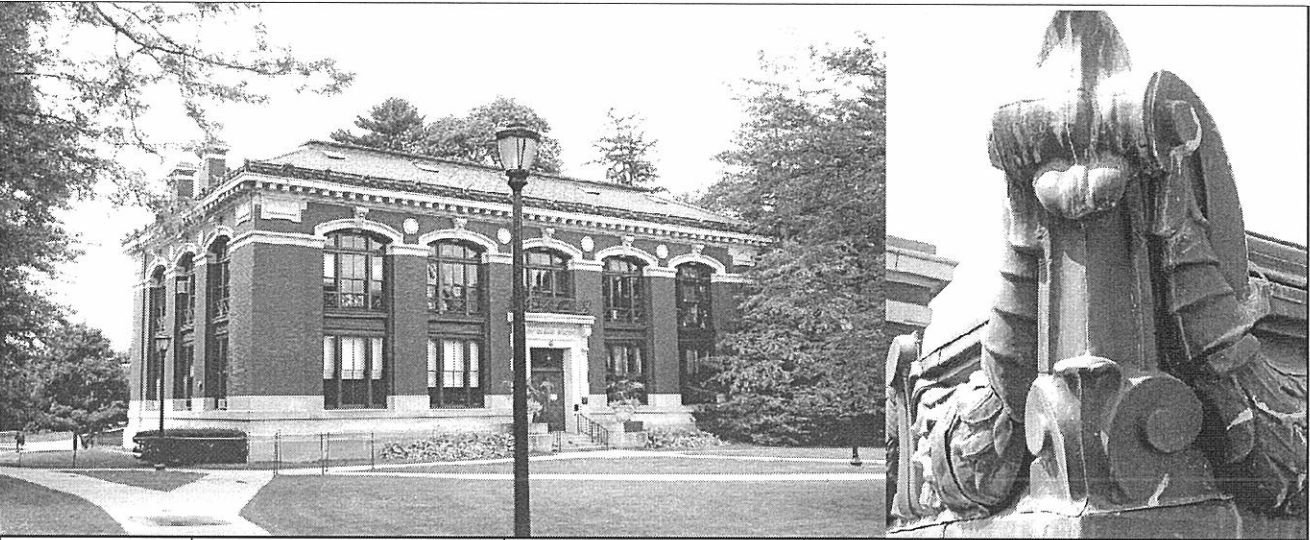
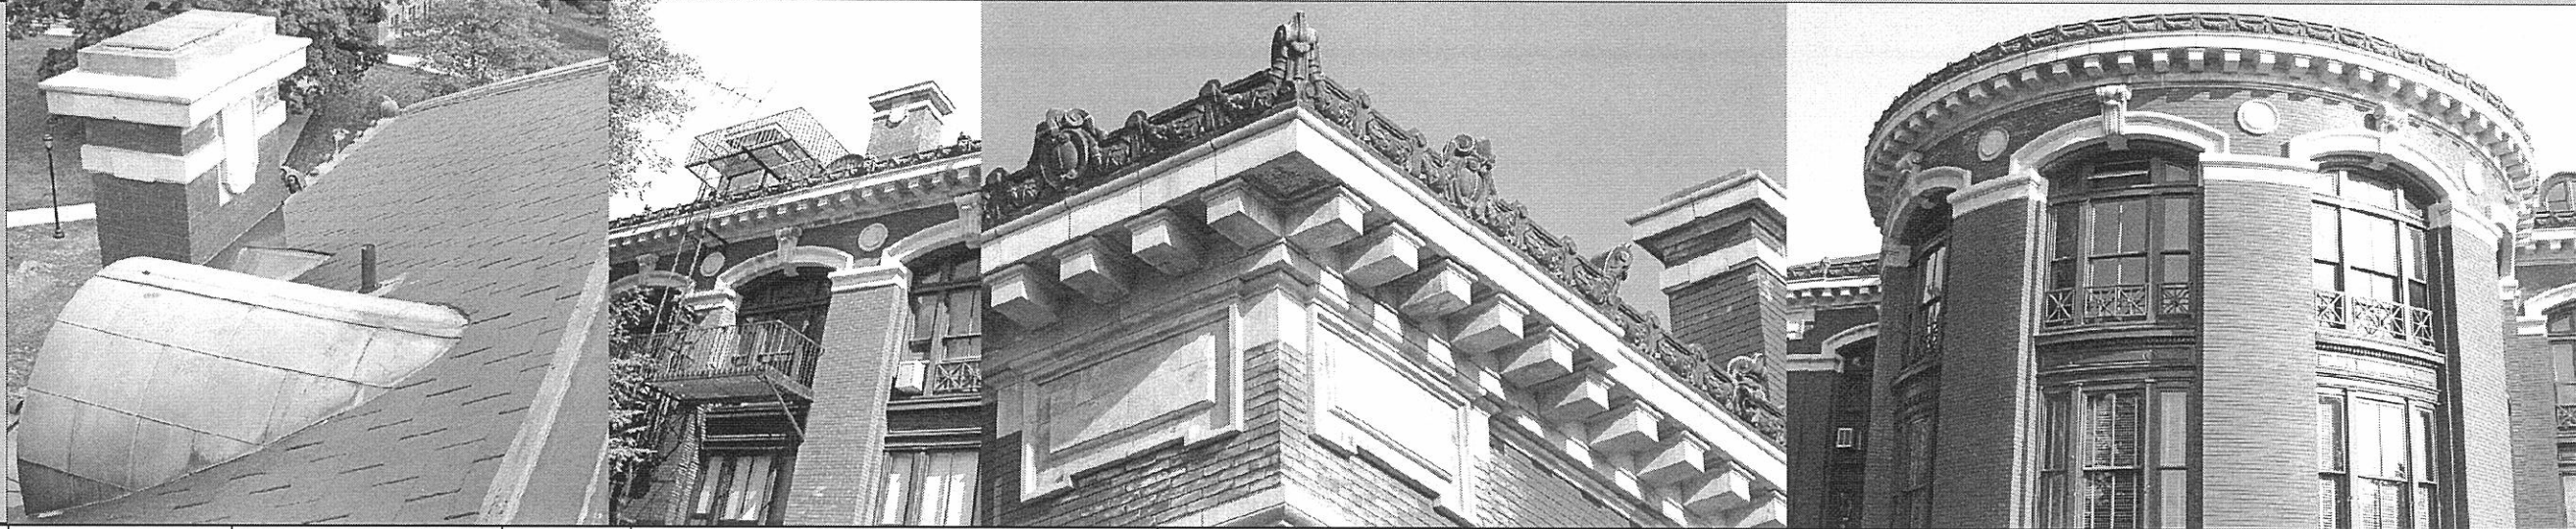
Item	Year of Installation	End of Service Life Year				2007	2008- 2010	2011- 2016	2017+		
1	Roof Construction														
1a	Low Slope Roof	Original flat-seam copper. Replaced with 0.060 adhered EPDM.	Fair	Adhered EPDM	1991	2011	Weathertight; draining	Limited review, 2004. Minor repairs, 2005.	Replace at end of service life.			X		30	Coordinate with roof rehabilitation project.
				Ferrous ridge at transition from EPDM to slate					Replace with long durability material when EPDM replaced.			X		60	
1b	Pitched Roof	Mansard, Buckingham Black Slate	Excellent	All slopes	1901	2161	Weathertight, aesthetically pleasing.	Limited review, 2004. Paint repairs, 2005.	No recommended action.					Unlimited with maintenance.	New high performance paint system: three coat epoxy-aliphatic polyurethane, with anticipated service life of 20 yrs.
		Ferrous hip and ridge covers	Excellent		1991	Unlimited with maintenance.	Weathertight, aesthetically pleasing.	Limited review, 2004. Minor repairs, 2005.	No recommended action.					150+	Although this type of slate has extremely long durability, it was glued down during installation. As such, any attempts to remove a single slate will likely break several slates.

1c	Other, Gutter	Decorative copper gutter with stamped copper fascia.	Poor	Copper gutter liner	1991	2007	Weathertight, Draining	Limited review, 2004. Minor repairs, 2006.	Dismantle gutter system, salvage decorative fascia, and install redesigned gutter system with additional drains.		X			60	Original painted, galvanized steel gutter system replaced in 1991 with copper-based assembly. Coordinate rehabilitation with roof rehabilitation project.
				Decorative copper fascia				Limited review, 2004.			X			60	
1d	Other, Dormers	Flat-seam copper-clad dormers.	Fair	Numerous breaches in system are protected by underlying waterproofing membrane.	1991	2007	Weathertight, Draining	Limited review, 2004 & 2006.	Dismantle dormers and reconstruct.		X			60	
1e	Other, Chimneys	Terra cotta capped brick masonry.	Good	Missing finial on south-west cupola.	1901	Unlimited with maintenance.	Weathertight, Draining	None	Restore missing elements and repair open seams and breaches.		X			NA

1f	Other, Skylights	Galvanized steel framed assemblies.	Fair	All units.	1991	2041	Weathertight, optically transparent.	Limited review, 2003, 2005.	No recommended action.					50

Item	Year of Installation	End of Service Life Year				2007	2008- 2010	2011- 2016	2017+		
2	Exterior Walls Construction Exterior Wall Construction														
2a	Mass Masonry Composite	Brick Masonry	Good	All elevations.	1901	Unlimited with maintenance.	Weathertight, structurally sound, clean	Restoration, 1991. Limited review, 2004.	Replacement		X			Unlimited with maintenance.	
2b		Limestone	Good		1901		Weathertight, structurally sound, clean	Restoration, 1991. Limited review, 2004.	Inspect/monitor annually, pinning or removing unstable regions locally as needed		X			Unlimited with maintenance.	
2c		Terracotta	Fair	All units.	1901		Weathertight, structurally sound.	Restoration, 1991. Limited review, 2004. Minor repairs, 2006.	Leaking gutter may have deteriorated ferrous armature, and intervention may be required.		X			Unlimited with maintenance.	
3	Windows Windows														
3a	Operable	Composite wood sashed, single-hung assemblies.	Fair-Poor	All units.	1901	Unlimited with maintenance.	Weathertight, optically transparent.	Restoration, 1991. Minor review, 2003.	Paint system renewal.		X			Unlimited with maintenance.	Coordinate with roof rehabilitation project.

4	(Other Building Components- as required) (Other Building Components- as required)														
4a	Main entrance	Limestone assembly featuring piece of Plymouth rock in door head surround.	Good	North elevation.	1901	Unlimited with maintenance.	Weathertight, structurally sound, aesthetically pleasing.	Restoration, 1991. Limited review, 2003	No recommended action.

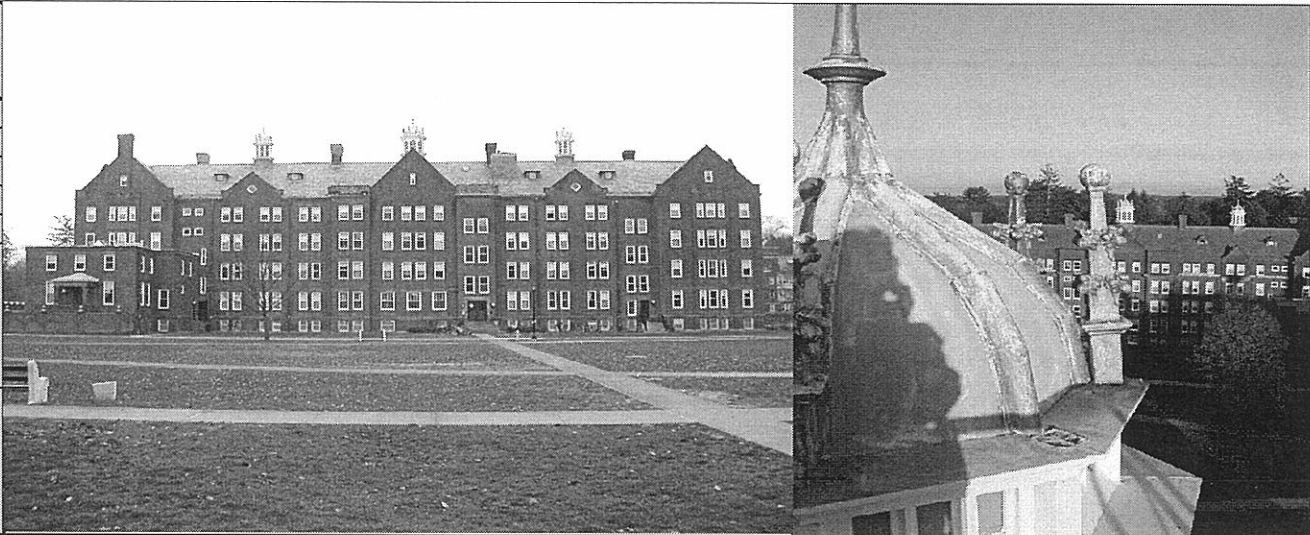
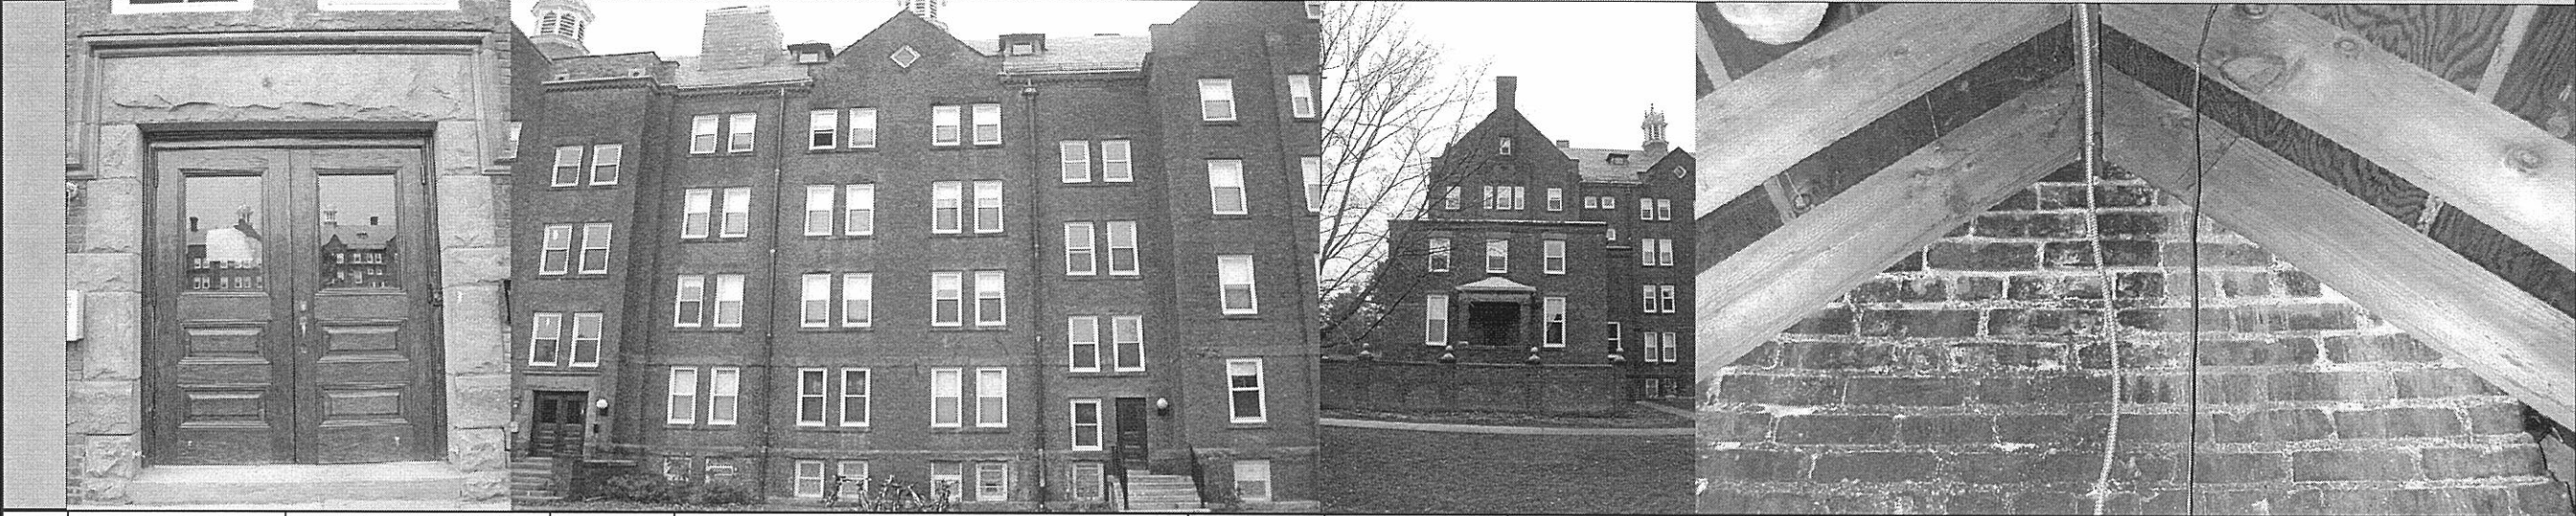
Item	Year of Installation	End of Service Life Year				2007	2008- 2010	2011- 2016	2017+		
1	Roof Construction														
1a	Pitched	Pennsylvania black slates, numerous replacements.	Poor	All slopes.	1960	2010	Weathertight	Limited review and repairs, 2005.	Full roof replacement required with longer durability slate.		X			100+	Roof replacement needs to be coordinated with masonry rehabilitation project, including chimneys.
		Copper flashings and built-in gutter system.	Fair-Poor	All areas	1960	2010	Weathertight, Structurally Sound	Limited review and repairs, 2005.			X			60	
1b	Low Slope	Low-rise portion of building, presumably with coal tar system.	Fair	Localized area.	Unknown, presumed 1980	2010	Weathertight	None	Replace as part of a full roof rehabilitation.		X			Depends upon selected system.	
1c	Other, Chimneys	Five chimneys constructed with multi-wythe masonry and capped with bluestone. Multiple flue openings, some of which have been capped.	Fair-Poor	Deteriorated masonry from on-going exposure and trapped vapor from flue caps.	1902	2007	Clear, Weathertight, Structurally Sound	Limited review in 2004, and two stabilized with netting.	Full repointing of all chimneys and new flashing systems. Two require partial rebuild of top portion.		X			50+	Ideally, this work phased in advance of roof replacement project.

1d	Other, Dormers	Pennsylvania black slates, numerous replacements.	Poor	All slopes.	1960	2010	Weathertight	Limited review, 2005.	Replace slate with full roof replacement.		X				
1e	Other, Cupolas	Timber framed, louvered painted walls with painted terne cap.	Fair	Louvers leak, and finials have been falling off.	1902	Unlimited with maintenance.	Weathertight, Aesthetically pleasing.	Limited review, 2004.	Review conditions, and restore paint system. Secure or replace loose finials.		X				Unlikely all present components are original, and further investigation required.
2	Exterior Walls Construction														
2a	Mass Masonry, Composite	Typical walls: Brick masonry.	Fair	Areas under gutters and coping stone mortar joints are open.	1902	Unlimited with maintenance.	Weathertight, structurally sound.	Limited review in 2004, and stabilization in 2005.	Address roofing, then repoint affected areas. Remove coping stones and reset atop through-wall flashing.		X			Unlimited with maintenance.	Improving the roof drainage system will decrease rate of deterioration.

Brownstone trim elements: typical window lintels, coping stones, beltcourse.	Fair	Open mortar joints undermine weathertightness.	1902	Unlimited with maintenance.	Weathertight.	Limited review, 2004.	Seal cracks or replace unit to restore weathertightness.		X				
2b	Mass Masonry, Composite	Parapets: Brick masonry capped with brownstone.	Fair	Similar to chimneys, on-going exposure has deteriorated masonry. North-east parapet rebuilt, 2005.	1902	2006	Structurally stable.	Limited review, 2004, and rebuild of north-east, 2005.	Rebuild parapets to restore appearance and structural stability.		X			100+

Item	Year of Installation	End of Service Life Year				2007	2008- 2010	2011- 2016	2017+		
3	Windows														
3a	Operable, single-hung.	Wood frame and sashes.	Fair	Window frames not sealed at perimeter, aesthetic concerns.	1980	2010	Weathertight, aesthetically pleasing.	None	Review window systems and replace with long service life option.		X	X		30	Windows appear to remain functional but are nearing end of service life.
4	(Other Building Components- as required)														
4a	Mass Masonry, Composite	Main Quadrangle entrance: original brownstone elements, proesumed to be framed by brick piers.	Fair	Weathered appearance is aesthetically displeasing.	1902	2006	Structurally stable, aesthetically pleasing.	Limited review, 2004 and 2006.	Rebuild 100%.		X			Unlimited with maintenance.	To be coordinated with plans for interior renovation of residence hall.
4b	Mass Masonry, Composite	Main Road entrance: original brownstone elements, new brick.	Excellent	Entire staircase rebuilt, 2005.	2005	2105	Structurally stable, aesthetically pleasing.	Rebuilt in 2005.	No recommended action.

4c	Mass Masonry, Composite	Low-rise staircase: steel framed with concrete, brick, bluestone, and brownstone composite masonry.	Fair	Staircase partially rebuilt, but on-going deterioration and corrosion of steel.	1985	2015	Structurally stable, aesthetically pleasing.	Limited review, 2006.	Selective rebuild, replacement of staircase treads, localized masonry repairs.			X		40	Condition of staircase does not mandate immediate intervention, but may consider coordination of this rehabilitation within larger masonry program planned for 2009.

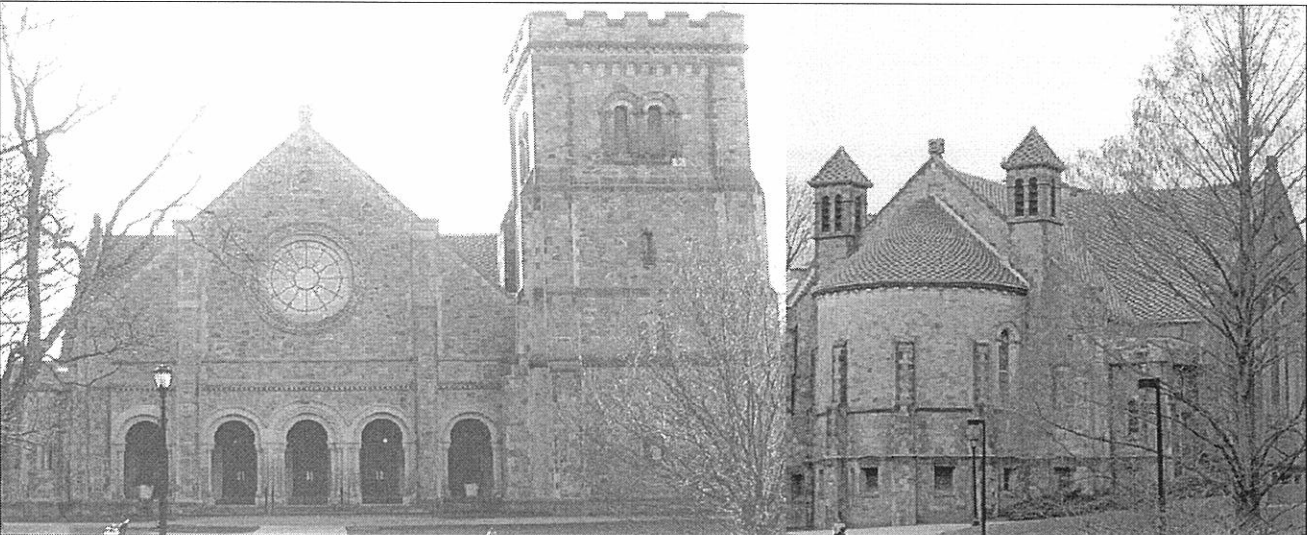
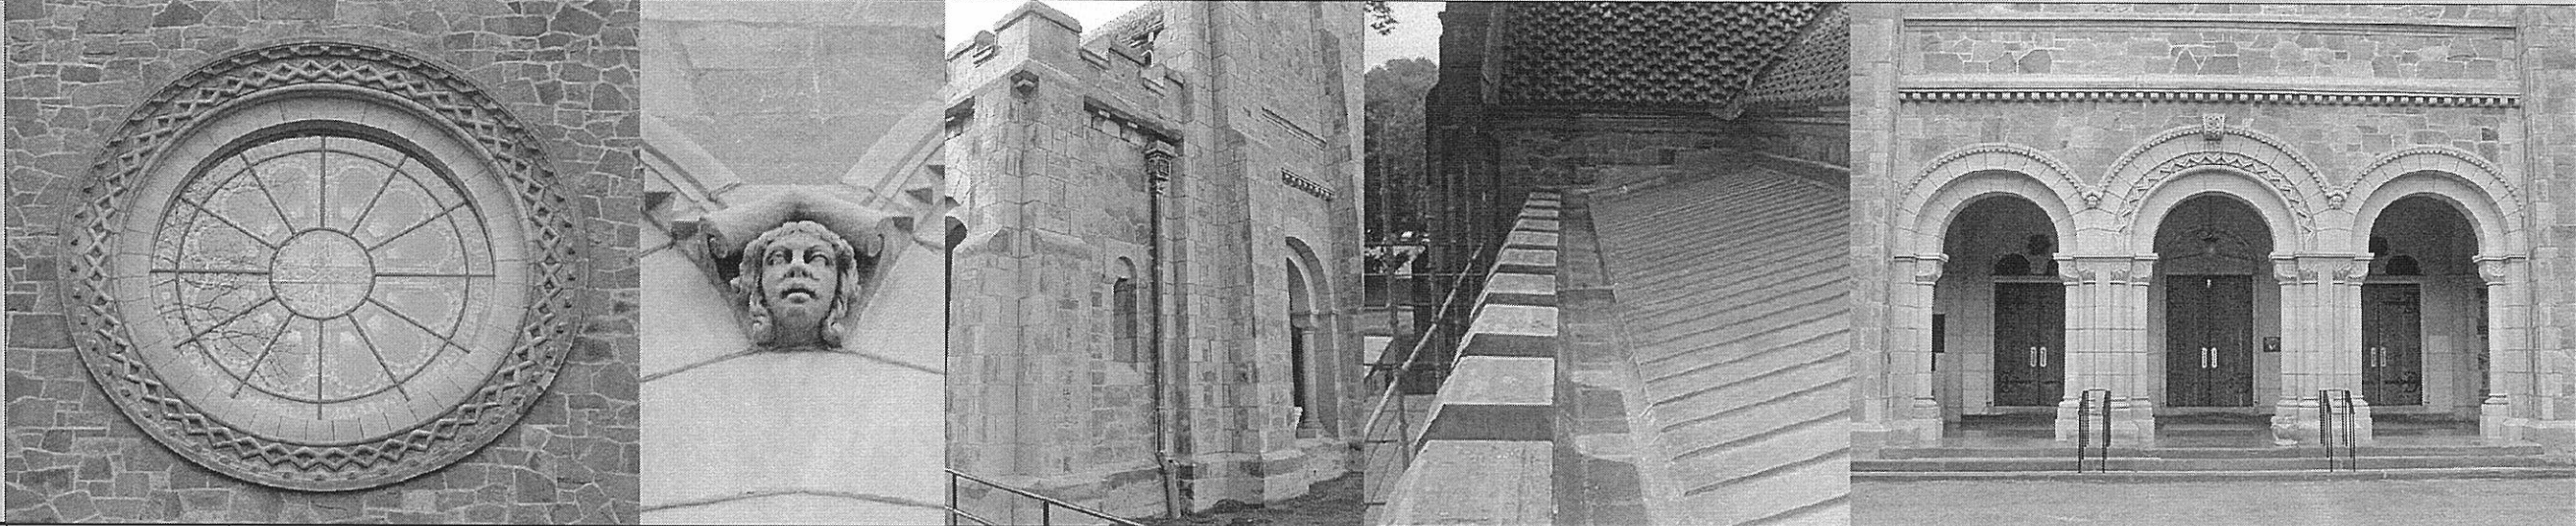
Item	Year of Installation	End of Service Life Year				2007	2008- 2010	2011- 2016	2017+		
1	Roof Construction														
1a	Pitched	Red Ludowici Conosera clay tiles	Good	All slopes.	1904	2054	Weathertight	Limited review and repairs, 2005.	Remove and salvage tiles to replace felts and flashings; reset tiles.		X			100+	Roof replacement needs to be coordinated with masonry rehabilitation project, including chimneys.
		Copper flashings and built-in gutter system.	Fair-Poor	All areas	1904	1979	Weathertight, Structurally Sound	Limited review and repairs, 2005.			X			60	
1b	Low Slope	Standard adhered EPDM	Fair	Tower	1990	2010	Weathertight	None	Replace with new roofing system.		X			Depends upon selected system.	
2	Exterior Walls Construction														
2a	Mass Masonry, Composite	Typical walls: Cape Ann Granite with sandstone detailing	Good-Fair	Areas under gutters and coping stone mortar joints are open.	1904	Unlimited with maintenance.	Weathertight, structurally sound.	Limited review in 2004, and stabilization in 2005.	Address roofing, then repoint affected areas. Remove coping stones and reset atop through-wall flashing.		X			Unlimited with maintenance.	Improving the roof drainage system will decrease rate of deterioration.

Sandstone trim elements: typical window lintels, coping stones, beltcourse.	Good-Fair	West elevation, north transept, and east cloister (excluding tower).	1904	Unlimited with maintenance.	Weathertight.	Restoration in 2003 and 2004.	No recommended action.						
		Sandstone trim elements: typical window lintels, coping stones, beltcourse.	Good-Fair	All elevations except north transept, west elevation, and east cloister.	1904	Unlimited with maintenance.	Weathertight.	Limited review, 2004.	Repoint, repair/replace heavily deteriorated stones and clean elevations.			X			
2b	Mass Masonry, Composite	Parapets: Cape Ann Granite capped with sandstone	Fair	Similar to chimneys, on-going exposure has deteriorated masonry. North-east parapet rebuilt, 2005.	1904	Unlimited with maintenance.	Structurally stable.	Limited review, 2004, and rebuild of north-east, 2005.	Rebuild parapets to restore appearance and structural stability.		X			100+

Item	Year of Installation	End of Service Life Year				2007	2008- 2010	2011- 2016	2017+		
3	Windows														Windows
3a	Operable, single-hung.	Wood frame and sashes.	Fair	Window frames not sealed at perimeter, aesthetic concerns.	1904	2010	Weathertight, aesthetically pleasing.	none	Review window systems and replace with long service life option.		X	X		30	Windows appear to remain functional but are nearing end of service life.
3b	Miscellaneous Inoperable stained glass assemblies	Tiffany, Dodge & LaFarge glass with lead tracery	Good-fair	Tiffany & Dodge on East, LaFarge on West.	Various	Unlimited with maintenance.	Weathertight, aesthetically pleasing.	Limited review in 2004.	No recommended action.						
3c	Inoperable, Stained Glass "Rose" Window	Tiffany rose window with lead tracery	Excellent	North gable.	1904	Unlimited with maintenance.	Weathertight, aesthetically pleasing.	Full restoration of window including sandstone surround in 2003.	No recommended action.

3d	Composite Operable & Inoperable leaded glass windows	Steel-framed, leaded glass windows	Excellent	West transept	2004	2080	Weathertight, aesthetically pleasing.	Replacement in 2004.	No recommended action.						Rather than restoration, the leaded glass windows are typically restored by replacing the glass with similar.
3e	Composite Operable & Inoperable leaded glass windows	Steel-framed, leaded glass windows	Fair-Poor	East transept	1904	2008	Weathertight, aesthetically pleasing.	Limited review in 2004, 2005, and 2006.	Replace assembly at end of service life, typically 80 years.		X				East transept is showing signs of deterioration but does not yet represent a structural concern.
3f	Composite Operable & Inoperable leaded glass windows	Steel-framed, leaded glass windows	Fair-Poor	Various locations of façade	1904	2008	Weathertight, aesthetically pleasing.	Limited review in 2004.	Replace assemblies at end of service life.		X				A phased replacement program will minimize intrusion on the building occupants.

4	(Other Building Components- as required)														(Other Building Components- as required)
4a	Mass Masonry, Composite	Towers framing apse with louvers	Fair	All parts	1904	2006	Structurally stable, aesthetically pleasing.	Limited review, 2004.	TBD		X			Unlimited with maintenance.

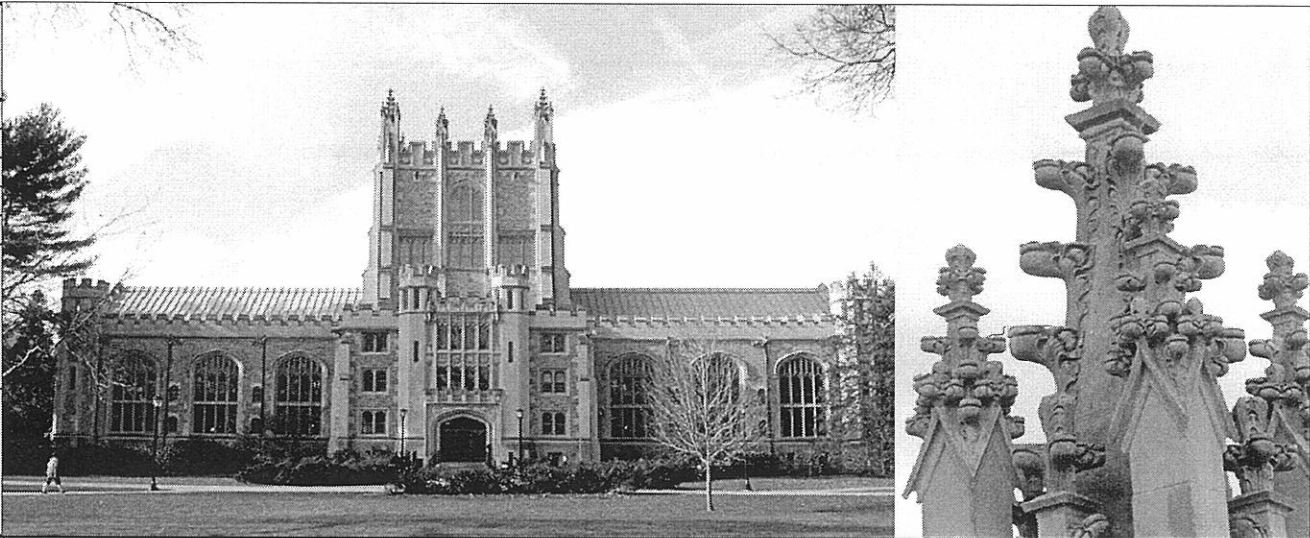
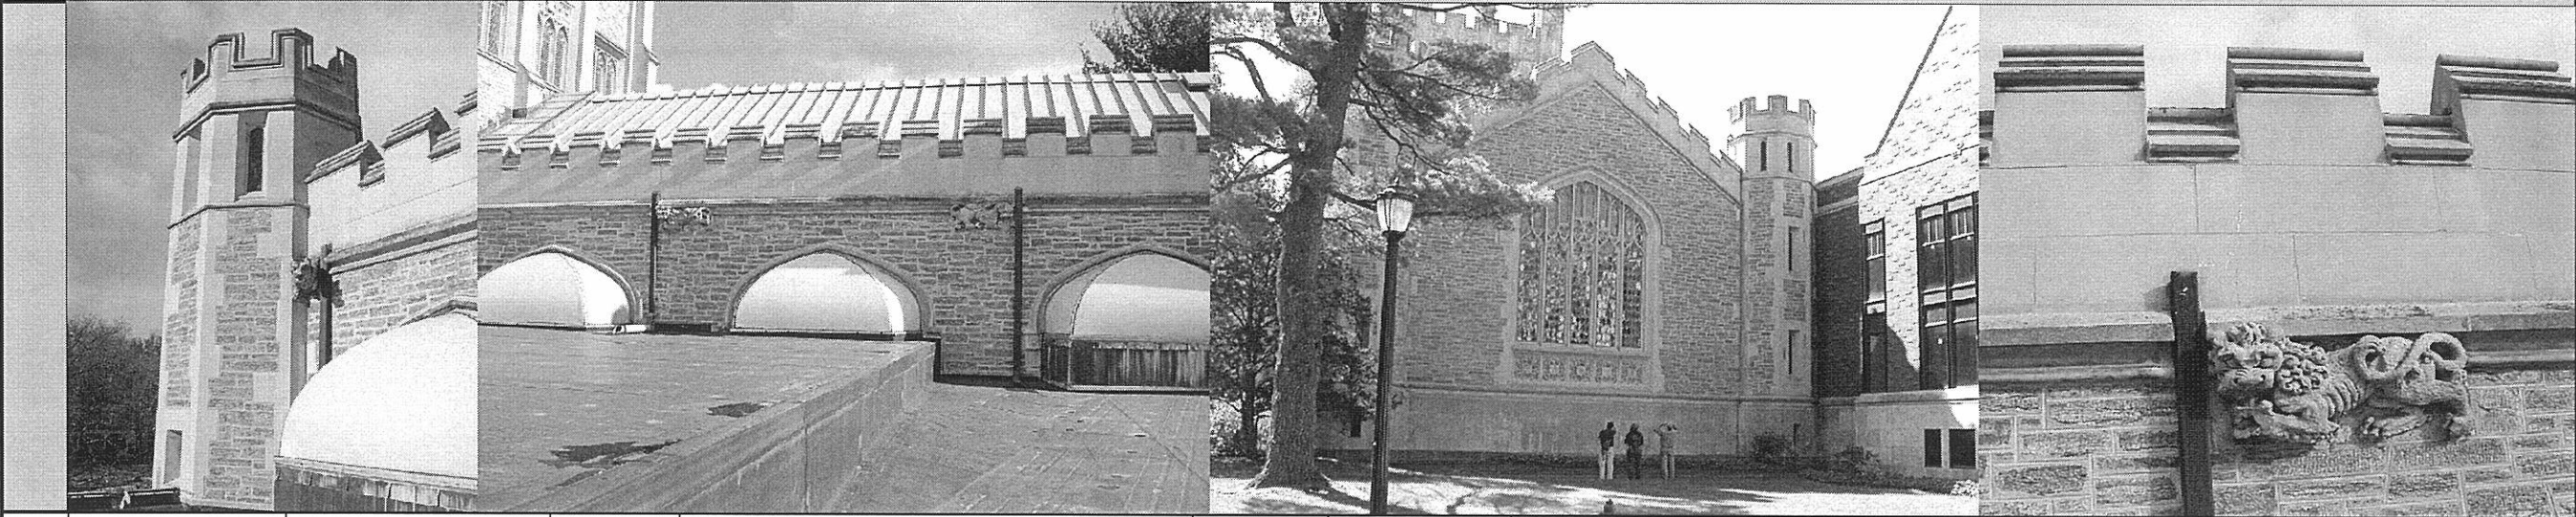
15	Frederick F. Thompson Memorial Library 1905/1918

Item	Year of Installation	End of Service Life Year				2007	2008- 2010	2011- 2016	2017+												
1	Roof Construction															Roof Construction									
1a	Pitched	Batten seam copper	Fair	All slopes	1968	2028	Weathertight	Limited review, 2004, 2005, 2006.	Repair/patch minor holes, deficiencies.	X				60											
		Multi-layers of built-up roofing protect built-in gutter	Poor	All slopes	1968	2007	Weathertight, draining.	Limited review 2004, 2005, 2006.	Replace in its entirety as part of gutter replacement program.	X				30	Original gutter system intended to be copper, but the configuration of the gutter makes watertight construction difficult and expensive.										
1b	Low Slope	Built-up roof	Fair	Main tower	Unknown, multiple layers.	2009	Weathertight, draining.	Limited review in 2004.	Replace in their entirety with long durability-low maintenance system.		X			Depends upon selected system.	Periodic review and maintenance repairs required.

Built-up roof and roofing cement.	Fair	Minor wing towers.	Unknown, multiple layers.	2009																			
		Built-up roof	Fair	Main entrance	Unknown, multiple layers.	2009																			
		Adhered EPDM	Excellent-Good	Interior spaces bounded by wings.	2001	2021	Weathertight, draining.	Limited review 2004.	No recommended action.					30											
2	Exterior Walls Construction															Exterior Wall Construction									
2a	Mass Masonry, Composite	Typical walls: granite masonry.	Good	All areas.	1905/1918	Unlimited with maintenance.	Weathertight, structurally sound.	Limited review, 2004.	No recommended action.					Unlimited with maintenance.											
		Typical walls: limestone trim elements.	Good	All areas.	1905/1918	Unlimited with maintenance.	Weathertight, structurally sound.	Limited review, 2004.	No recommended action.

Item	Year of Installation	End of Service Life Year				2007	2008- 2010	2011- 2016	2017+		
3	Windows														Windows
3a	Fixed	Leaded glass in steel sashes, framed in limestone.	Good	General elevations.	Unknown, assumed 1905/1918	1975	Weathertight, aesthetically pleasing.	Limited review, 2004.	Review and restore windows as required.					80	Steel sashes, etc. require periodic maintenance, and painting every 10 years to remain in serviceable condition.
3c	Fixed	Leaded or stained glass in limestone.	Good	General elevations.	Unknown, assumed 1905/1918	1975	Weathertight, aesthetically pleasing.							80	
4	(Other Building Components- as required)														(Other Building Components- as required)
4a	Entrances	Decorative limestone surround.	Excellent-Good	Main entrance	1905	Unlimited with maintenance.	Weathertight, secure, aesthetically pleasing.	Limited review, 2004.	No recommended action.					Unlimited with maintenance.	Periodic review and maintenance to maintain in serviceable condition.

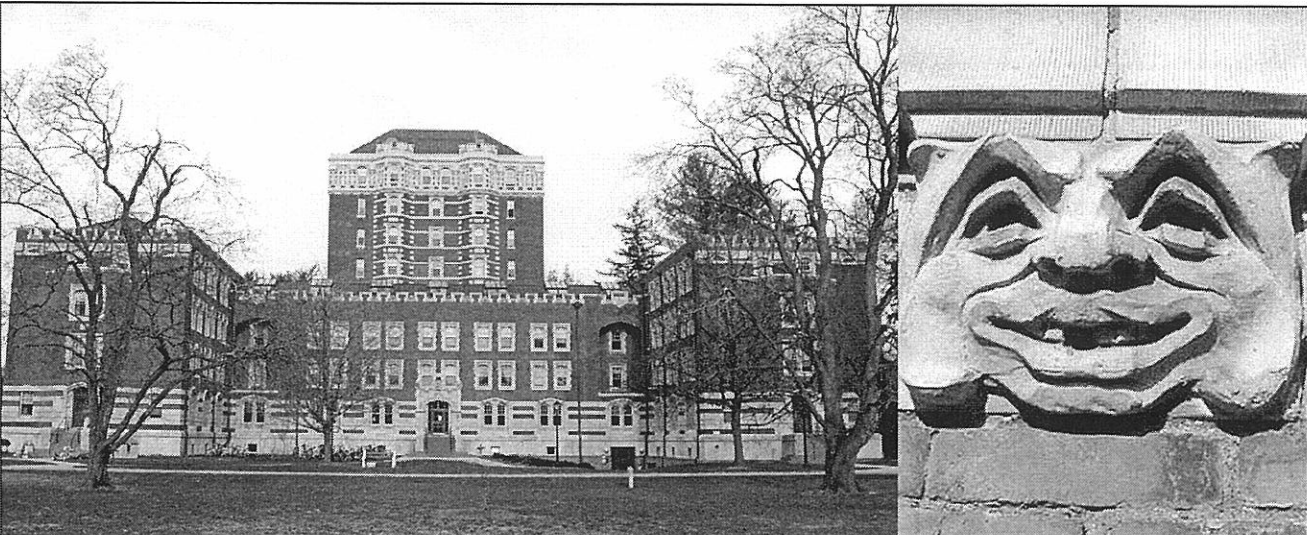
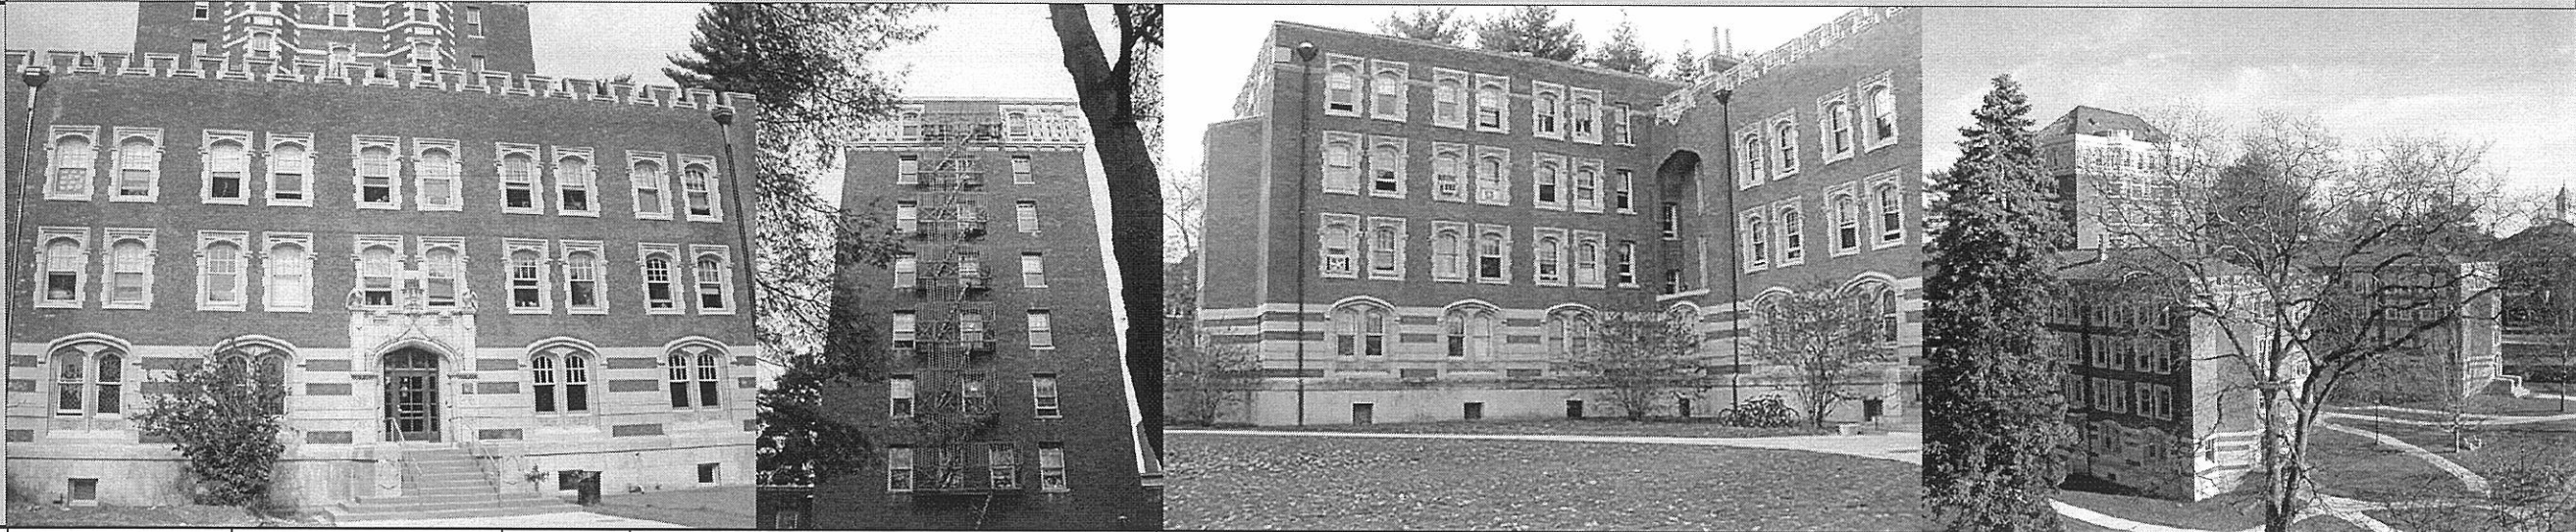
16	Jewett House 1907

Item	Year of Installation	End of Service Life Year				2007	2008- 2010	2011- 2016	2017+																			
1	Roof Construction															Roof Construction																
1a	Pitched	Standing seam copper with lead-coated copper built-in gutters.	Excellent	All slopes, both tower and low-rise	2003	2078	Weathertight	Full replacement during renovation in 2003.	No recommended action except periodic maintenance.					75																		
		Copper flashings and hanging gutter system.	Excellent	All slopes	2003	2063	Weathertight, draining.	Full replacement during renovation in 2003.	No recommended action except periodic maintenance.					60																		
1b	Low Slope	Ballasted EPDM.	Excellent	Link between low-rise and tower roof.	2003	2023	Weathertight, draining.	Full replacement during renovation in 2003.	No recommended action except periodic maintenance.					Depends upon selected replacement system.

1d	Other, Skylights	Steel-framed assemblies.	Excellent	Low rise, east-west central section.	2003	2063	Weathertight, aesthetically pleasing.	Newly installed during 2003 renovation.	No recommended action except periodic maintenance.					60																		
2	Exterior Walls Construction															Exterior Wall Construction																
2a	Mass Masonry, Composite	Typical walls: brick masonry.	Good	All elevations.	1907	Unlimited with maintenance.	Weathertight, structurally sound.	Restoration of terra cotta and brick in 2003. New installation of bluestone cladding in 2003.	No recommended action except periodic maintenance.					Unlimited with maintenance.	Bluestone was added as cladding when site resloped for new entrances.																	
		Typical walls: terra cotta and bluestone trim elements.	Good			Unlimited with maintenance.	Weathertight, structurally sound.																									
3	Windows															Windows

3a	Operable, single-hung	Wood frames and sashes with true divided lites.	Excellent	General elevations.	2003	Unlimited with maintenance.	Weathertight, aesthetically pleasing.	Full replacement during renovation in 2003.	No recommended action except periodic maintenance.					Depends upon selected replacement system.	Frames and sashes, etc. require periodic maintenance, and painting/sealing every 10 years to remain in servicable condition.																	
3b	Fixed	Leaded glass in painted wood frames and sashes.	Excellent	South, central elevation		2078

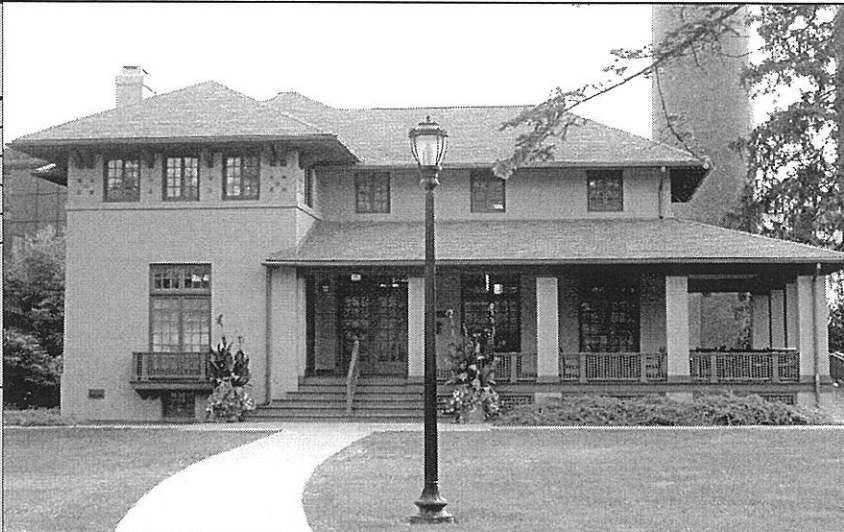
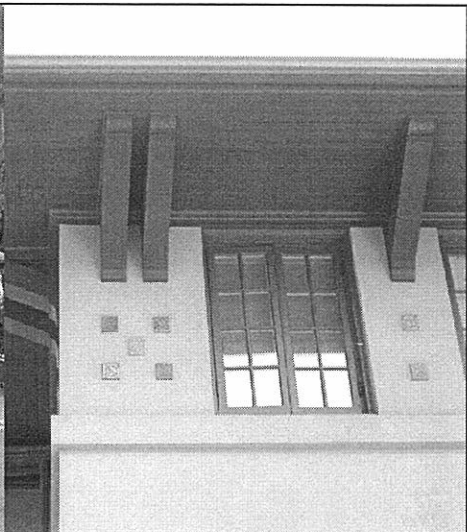
17	Carol & James Kautz Admission House 1908														
	Architect	Pilcher & Tachau				Reference Documents									
	Renovation Dates	1995 (Linda Yowell)				Architectural Drawings				Yes

Item	Year of Installation	End of Service Life Year				2007	2008- 2010	2011- 2016	2017+		
1	Roof Construction														
1a	Pitched	Three-tab, asphalt shingles covering both multi-hip roof configuration and porch roof.	Good	All slopes	1995	2020	Weathertight	Limited review, 2003.	No recommended action except for periodic review and maintenance.				X	50	Replace asphalt shingles with longest-term durability shingles available at end of service life of present system.
		Aluminum gutters and accessories.	Good-Fair	All slopes	1995	2020	Weatheright, Structurally Sound, Draining.		Repair minor leaks in gutters.		X			60	Wide eaves are protecting building from gutter leaks.
1b	Other, Chimney	Brick masonry clad in cementitious stucco	Good	North slope	1908	Unlimited with maintenance.	Weatheright, Structurally Sound, Draining.		No recommended action.					Unlimited with maintenance.	
2	Exterior Walls Construction

2a	Mass Masonry, Composite	Typical walls: Brick masonry clad in cementitious stucco.	Good-fair	All elevations.	1908	Unlimited with maintenance.	Weatheright, structurally sound.	Limited review, 2003.	No recommended action.					Unlimited with maintenance.	
		Elastomeric coating	Excellent	All elevations.	1995	2010	Weatheright, aesthetically pleasing.								
		Decorative tiles embedded with cementitious stucco	Excellent	All elevations.	1995	Unlimited with maintenance.	Aesthetically pleasing.

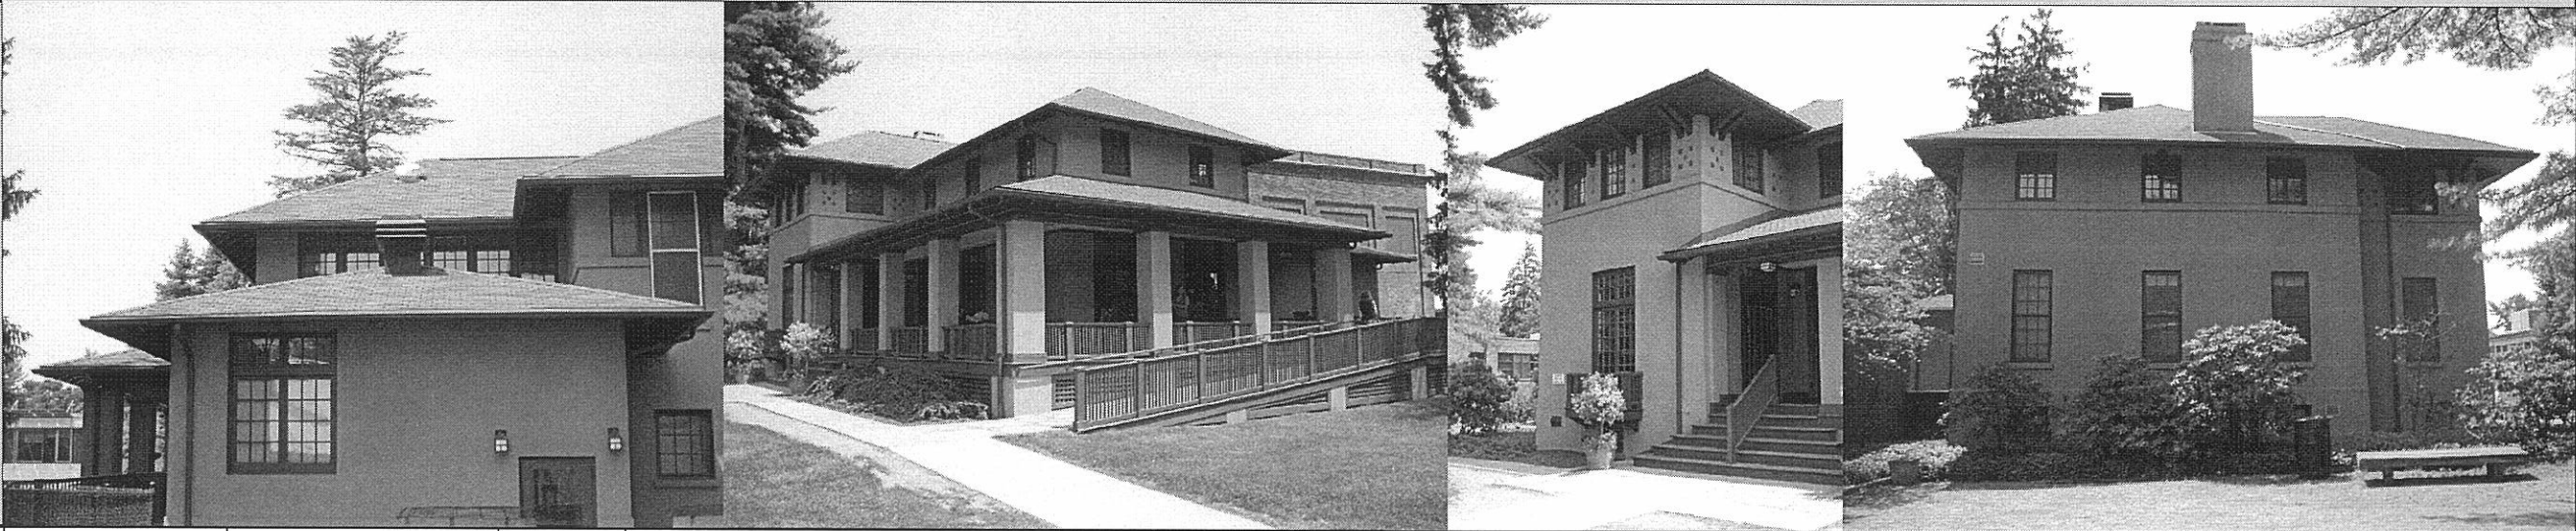
17 Carol & James Kautz Admission House

Item	Year of Installation	End of Service Life Year				2007	2008- 2010	2011- 2016	2017+		
3	Windows														
3a	Fixed	Composite windows with true divided lites, wood.	Good	Ground floor, west elevation.	1995	2045	Weathertight, aesthetically pleasing.	Limited review, 2003.	No recommended action.					50	Pre-existing frames were reused and rehabilitated to accept new sashes
		Individual windows within punched openings with true divided lites, wood.	Good	Ground floor, east elevation.	1995	2045								50	
3b	Operable	Double-hung windows with true divided lites, wood.	Good	Ground floor, north elevation.	1995	2045								50	
		Awning with true divided lites, wood.	Good	Lower level, north and east elevations.	1995	2045								50	
		Casement with true divided lites, wood.	Good	Predominantly second floor, all but west elevation.	1995	2045								50	
		French Casement with true divided lites, wood.	Good	Predominantly second floor, all elevations.	1995	2045								50

Transom with true divided lites, wood.	Good	Ground floor, south elevation atop fixed.	1995	2045								50	
4	(Other Building Components- as required)														
4a	Entrance	Composite doors with true divided lites, wood.	Good	Gound floor, west elevation	1995	2045	Weathertight, aesthetically pleasing.	Limited review, 2003.	No recommended action.
